Wood Destroying Insect Inspection Report

Inspection Company, Address & Phone
Coastline Pest Control
605 Twin Tree Road
Salisbury, MD 21801
410-546-0111

104 Middleneck Lane
Salisbury, Md 21804

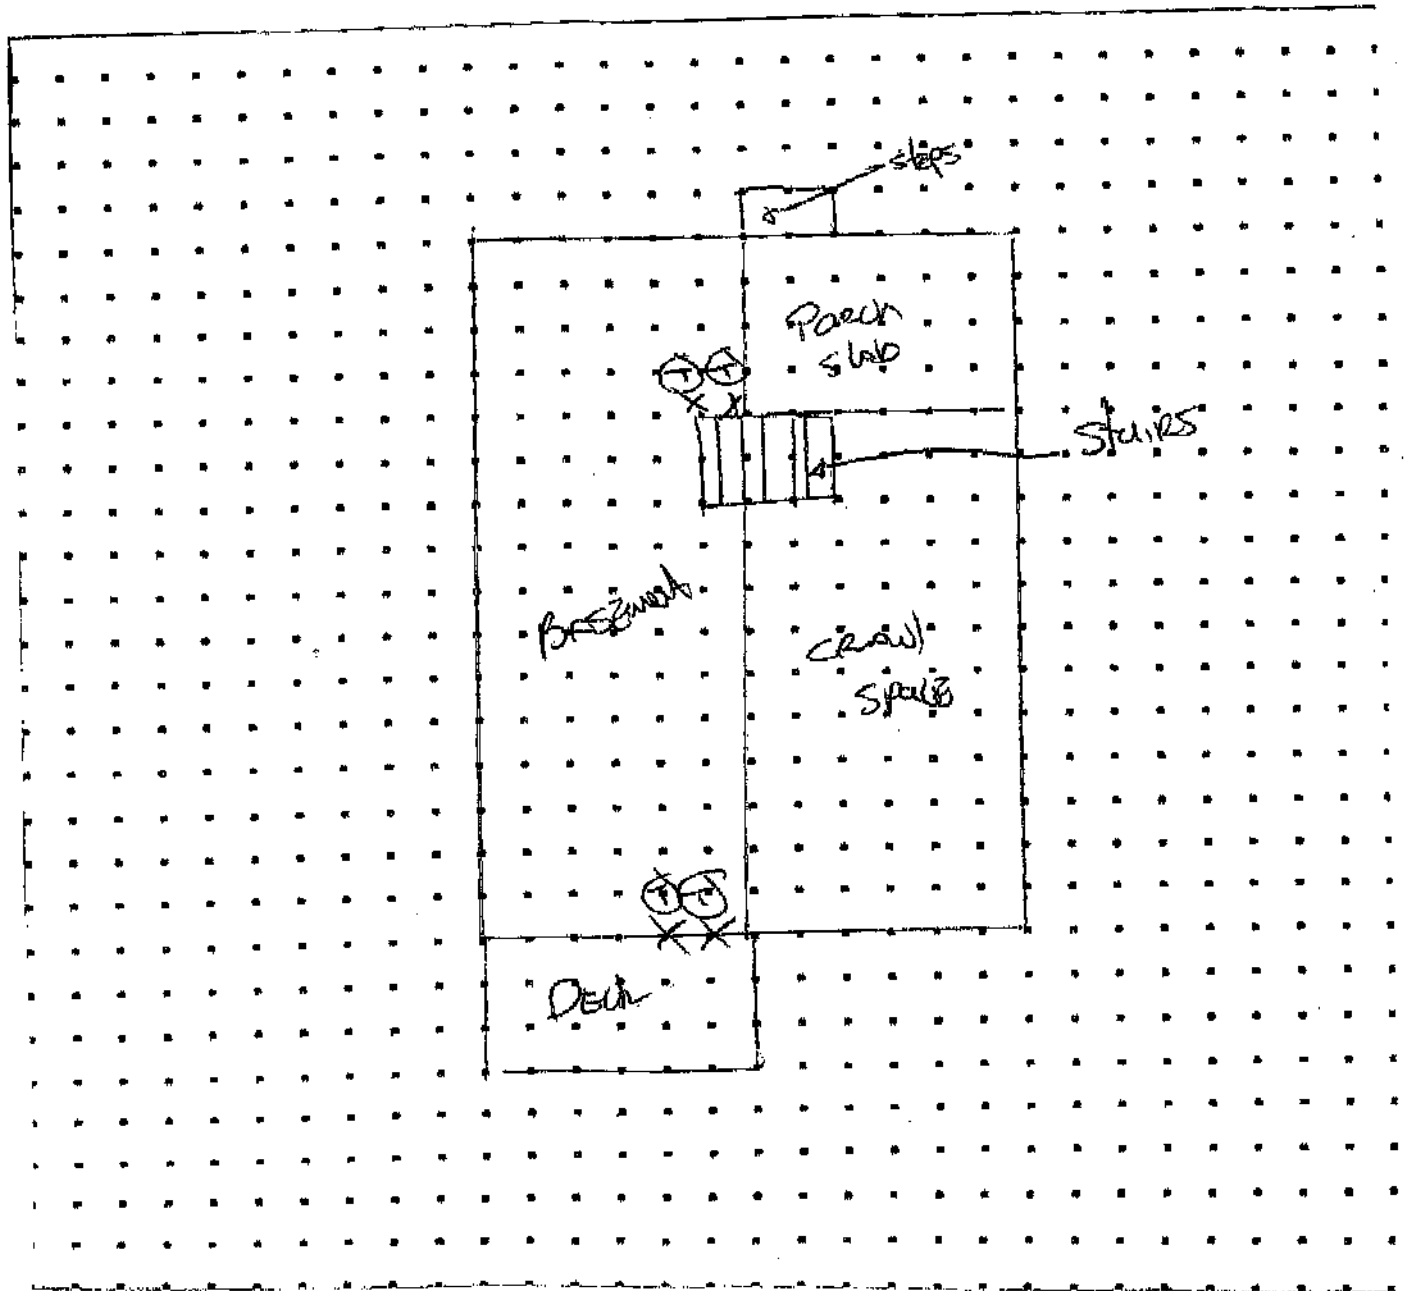
Graph

2. Dead insects, parts, frass, shelter tubes, exit holes, or staining (description and location): **previous sub-terranean termites located in base to floor joists and bandboard**

3. Visible damage from wood destroying insects was noted as follows (description and location): **previous sub-terranean termites located in base to floor joists and bandboard. (SEE DIAGRAM)**

No treatment recommended: (Explain if Box B in Section II is checked) **previously treated**
